# the play inspection company

# **Annual Inspection**

Marldon Parish Council

Marldon Play Area

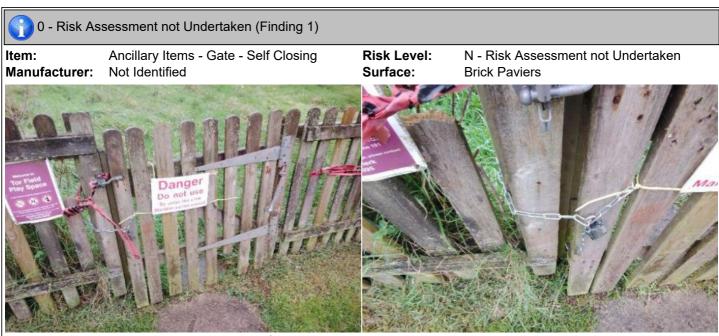
**Finding:** The gate was secured at the time of the inspection **Action:** Ensure that the gate closes between 4-8 seconds to prevent access to the site.

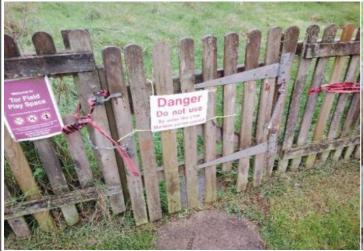
# 6 - Low Risk (Finding 2)

Finding: A number of fixing(s) have worked loose

**Action:** Secure all loose fixings

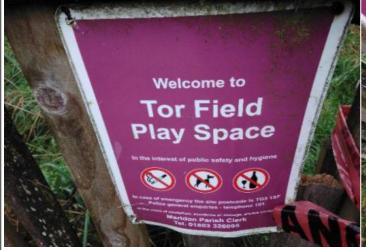
Finding: There is or are fixings missing on the item

**Action:** Replace all missing fixings

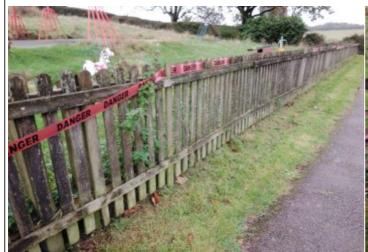
**Finding:** A post has rotted and sheared and the fence section is unstable

Action: Repair as required to secure

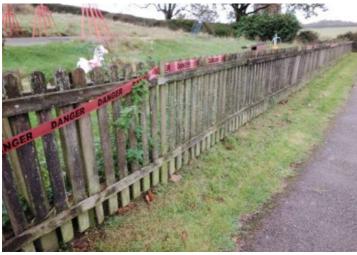
Finding: The fence is damaged in places

Action: Repair or replace all affected sections

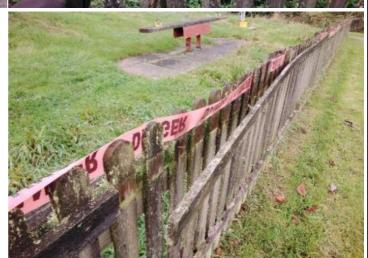
Finding: A number of fixings have pulled through two slats Action: Replace the slats and secure due to rot

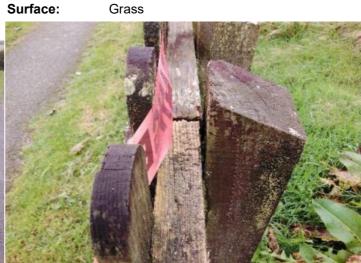
**Finding:** A number of fixings have worked loose around the **Action:** Secure all loose fixings fencing

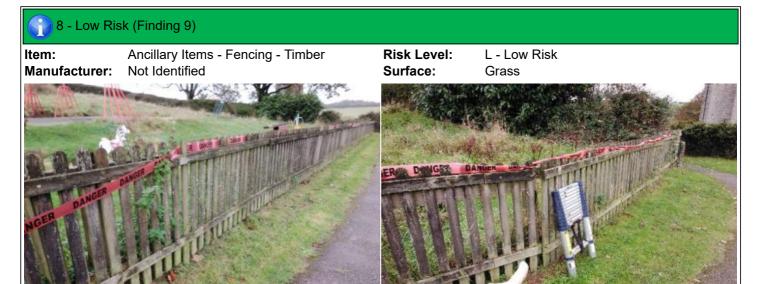
Finding: A post has rotted and sheared

Action: Replace

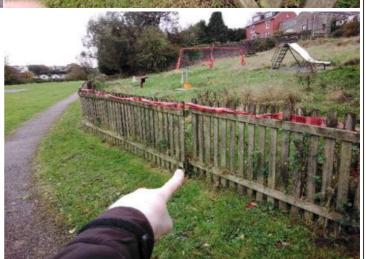
**Finding:** There are fixings missing and a section of fence is **Action:** Repair as required to secure unsecured

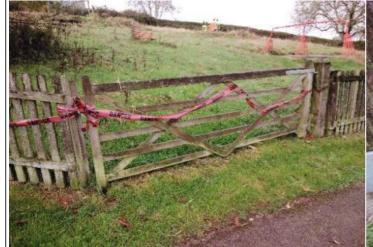
6 - Low Risk (Finding 2)

Finding: There is no padlock on the maintenance gate

Action: Provide a padlock to secure the gate

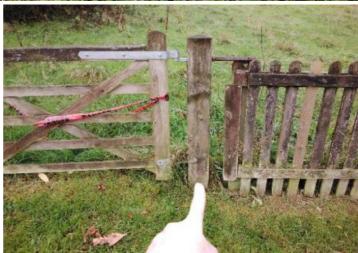
Finding: There is some evidence of rot in the timber post

**Action:** Monitor for any further deterioration and replace as required

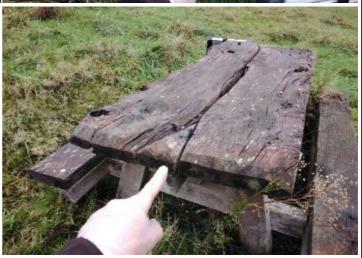
Finding: Two components are loose

Action: Repair as required to secure

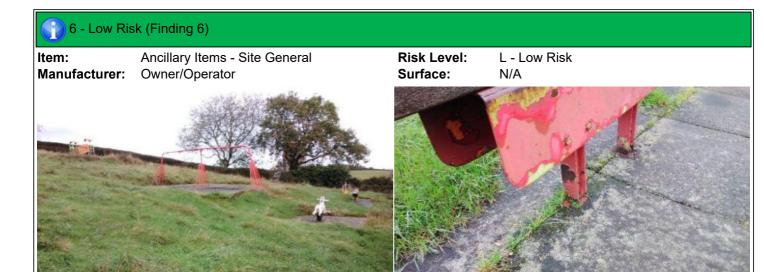
**Finding:** There are weeds/vegetation growth between or around the edges of the surfacing

Action: Remove weeds/vegetation growth

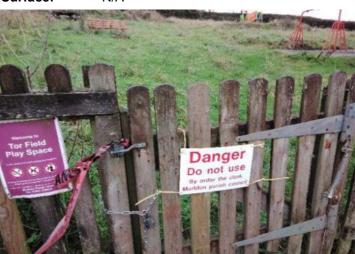
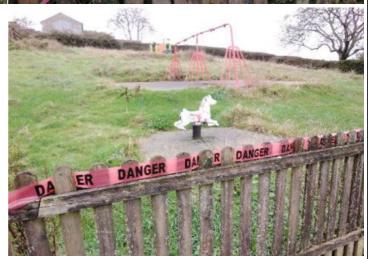
Finding: The site was closed to the public at the time of the Action: Monitor use and consider providing Heras securing inspection. The main access gate had been secured to prevent access and there are warning signs present. The site is however, still relatively easy to access and users have been reported entering the site to access/use the equipment

fencing to prevent further unauthorised access if required

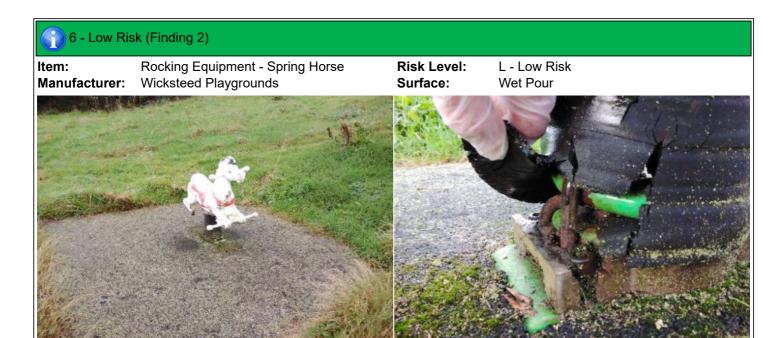
Finding: The spring clamps are loose

Action: Tighten all loose fixings

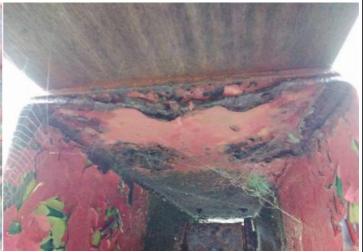
The structural frame of the unit is heavily corroded and a number of the mount / fixing points appear to be compromised. The structural integrity of the unit cannot be guaranteed. If the unit is to be retained on site, significant work will be required to the frame to ensure it retains its structural integrity and to prevent any further deterioration. -We would recommend that the structural frame of the unit is dismantled as far as possible and all components inspected for corrosion and to ensure continued structural integrity. Treat and repaint or replace any compromised components as required

Finding: The structural frame of the unit is heavily corroded Action: We would recommend that the structural frame of and a number of the mount / fixing points appear to be compromised. The structural integrity of the unit cannot be guaranteed. If the unit is to be retained on site, significant work will be required to the frame to ensure it retains its structural integrity and to prevent any further deterioration.

the unit is dismantled as far as possible and all components inspected for corrosion and to ensure continued structural integrity. Treat and repaint or replace any compromised components as required

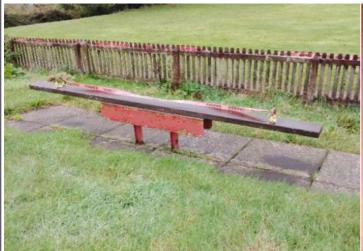
### 5 - Very Low Risk (Finding 2)

There is no gaiter protection for accessible moving parts (possible shear trap) as recommended in BS EN 1176 Part 1; 4.2.6 Moving Parts - Monitor - No remedial work recommended

**Finding:** There is no gaiter protection for accessible moving **Action:** Monitor - No remedial work recommended parts (possible shear trap) as recommended in BS EN 1176

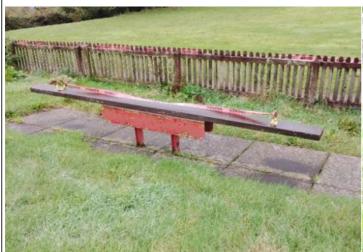
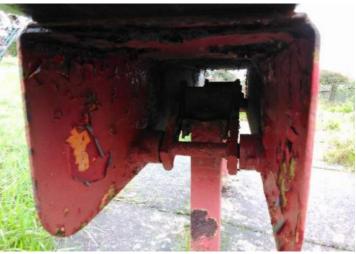
#### 6 - Low Risk (Finding 3)

**Finding:** There is some lateral movement in the mechanism **Action:** Monitor for any further deterioration and repair as required

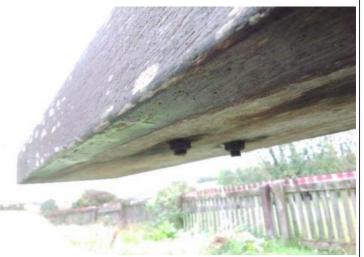
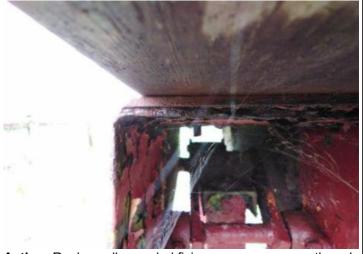
**Finding:** There are corroded projecting bolt thread(s) present

**Action:** Replace all corroded fixings, remove excess thread lengths and deburr or provide caps for all accessible bolts

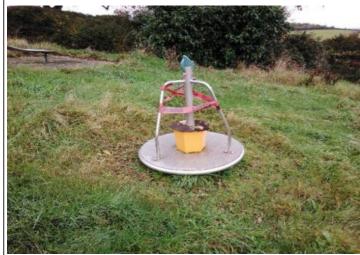
6 - Low Risk (Finding 1)

Finding: The cap is slightly loose

**Action:** Monitor for any further deterioration and secure as required

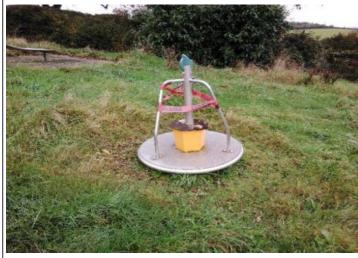
Finding: There is minor damage to the unit

**Action:** Monitor for any further deterioration and repair as required

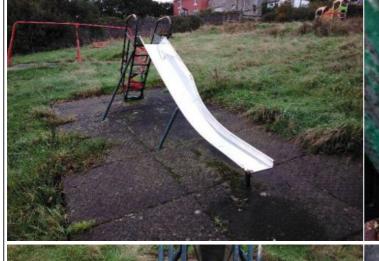
Parts of the steel on two steps have corroded excessively and the metal has perforated in places - Ensure all affected areas are treated and repaired

Action: Ensure all affected areas are treated and repaired

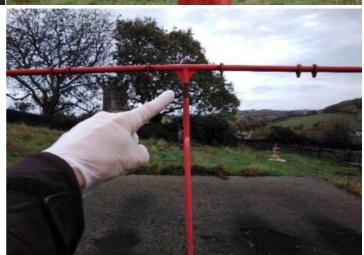
Finding: There is or are fixings missing on the central post Action: Refer to manufacturer, reinstate the crossbar on its and the crossbar has become unseated on the post mount

mount and replace all missing fixings. Ensure that the structure is fully secured.

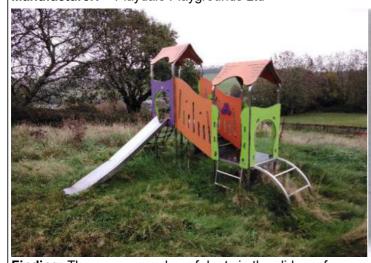
#### 4 - Very Low Risk (Finding 4)

Finding: There are a number of dents in the slide surface

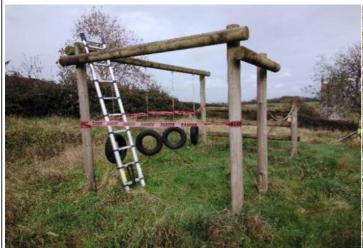
#### 6 - Low Risk (Finding 6)

**Finding:** There is some evidence of rot in the timber throughout

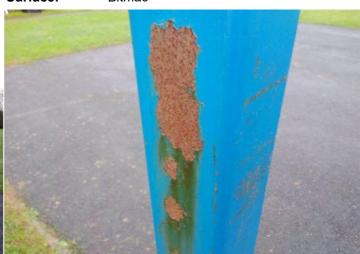
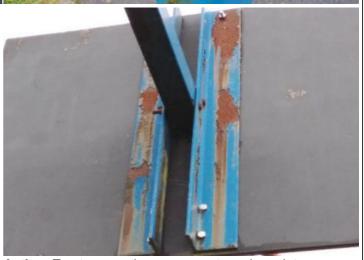
Finding: The paintwork on this item has been damaged or Action: Treat any rusting components and repaint worn exposing the metal underneath which is rusting
